# Carson Valley Trails Association

## 2023 Trail Operations Overview and 2024 Trail Work Plan

# Carson Valley Trails Overview-2023

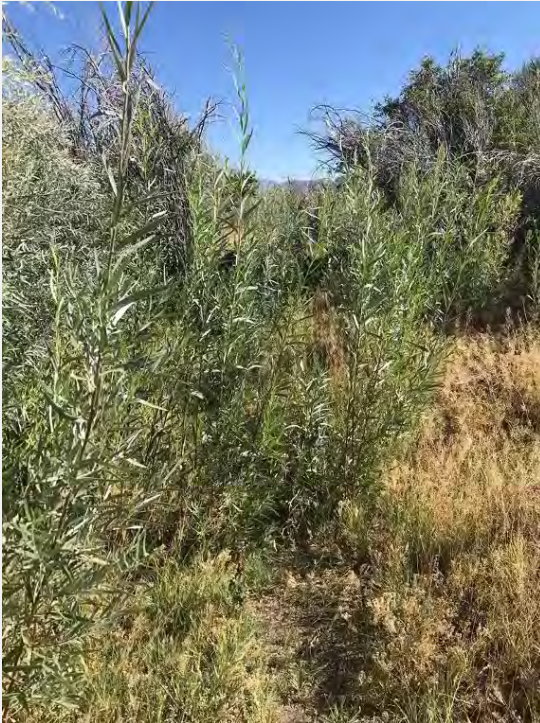
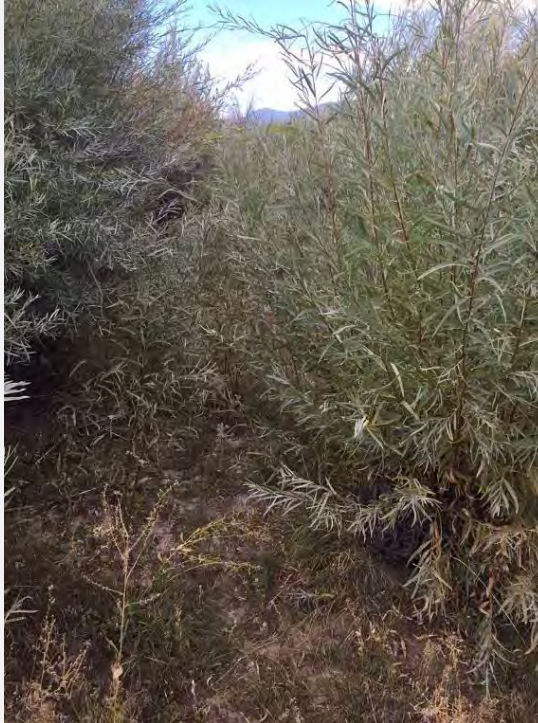
2) Encroaching growth of willows, roses, sagebrush and rabbitbrush was brushed out.

***Brushing***

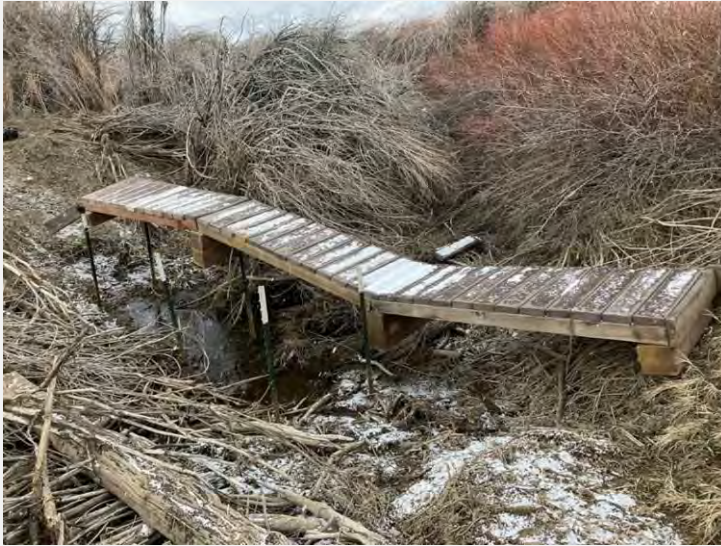
3) Boardwalk damages from several flood events were repaired.

***Boardwalk damage***

- c) Damage to boardwalks occur from routine flooding and regular freeze/thaw soil movement. These boardwalks allow people to walk across sections of trail that take longer to dry out after storms and floods. The repair and replacement of this infrastructure is sometimes frequent and time-consuming.

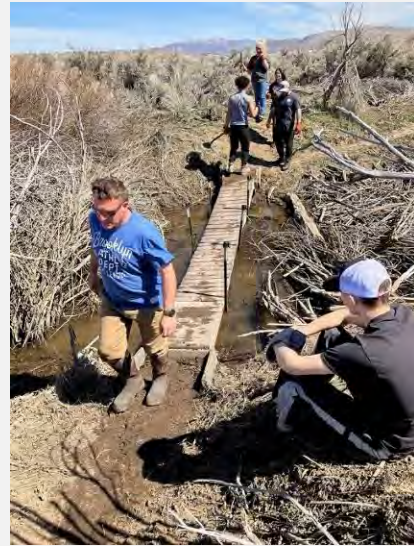
***Repair work***

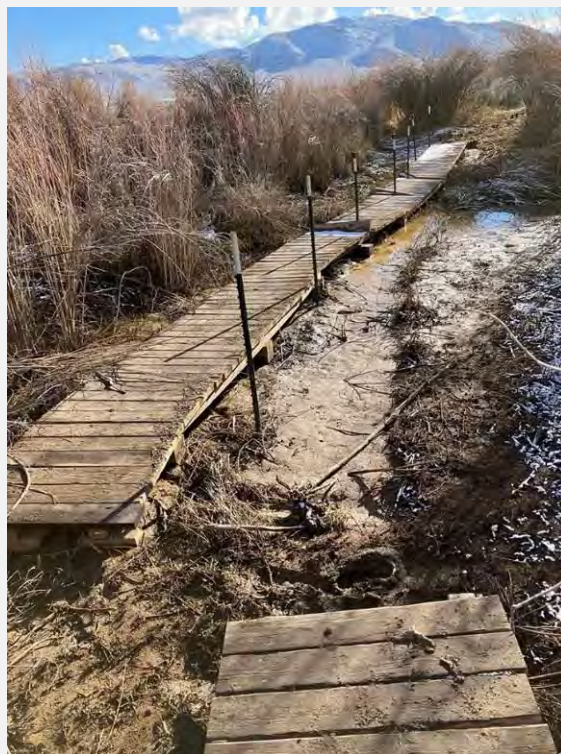
***Boardwalk damage***

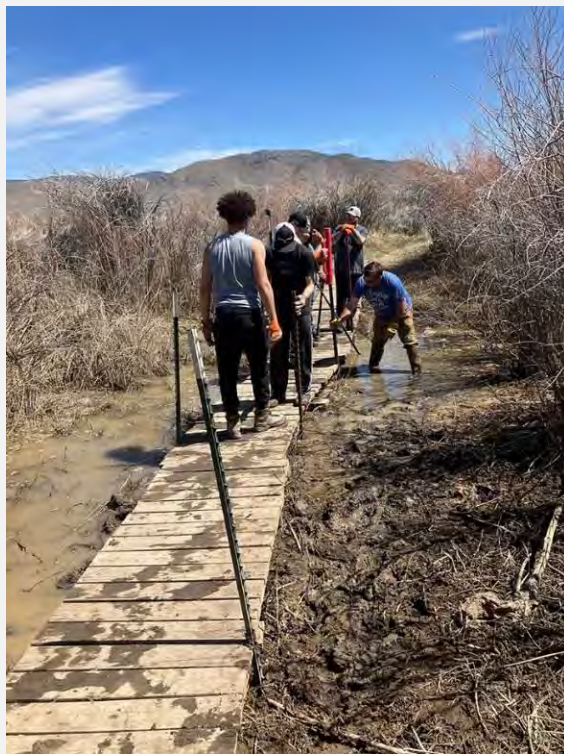
***Repair work***

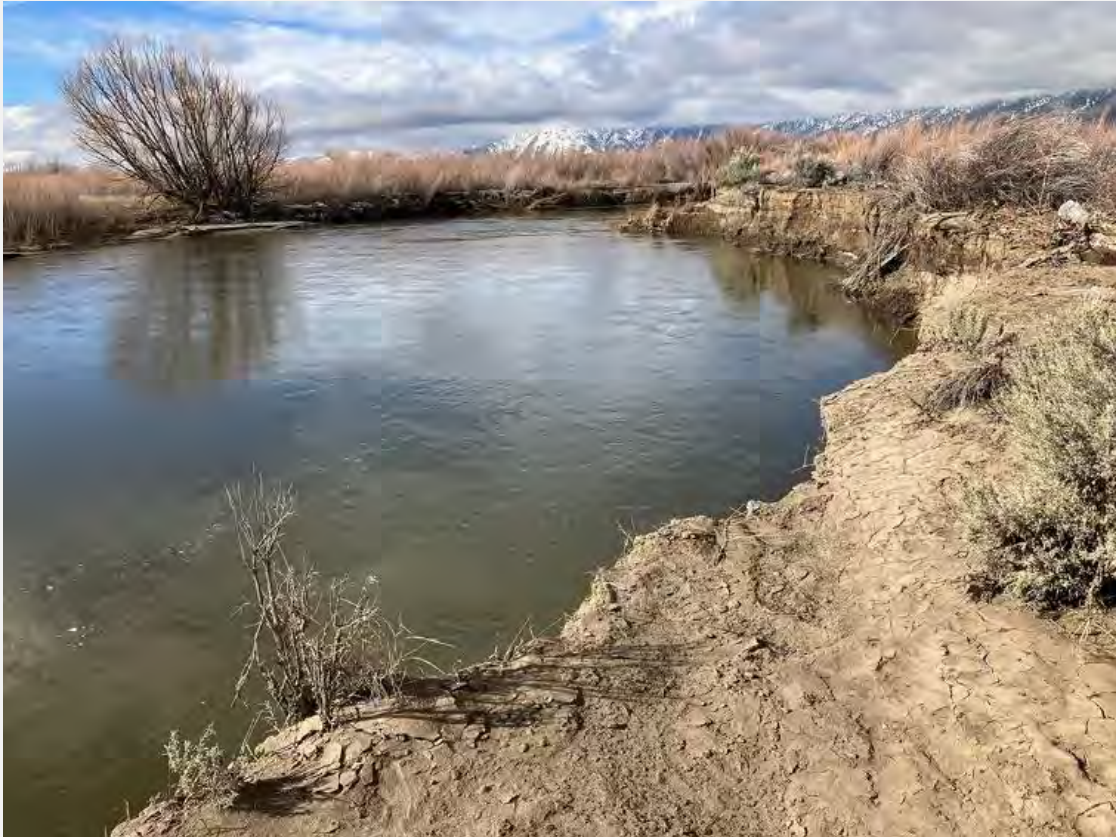
4) Flooding events have permanently washed away several trail sections.

*Trail section gone*

- b) Movement of the Carson River has eliminated seven trail sections in past years. Realignment has occurred but sometimes with the same result or needing moved into denser vegetation areas that get overgrown quickly.

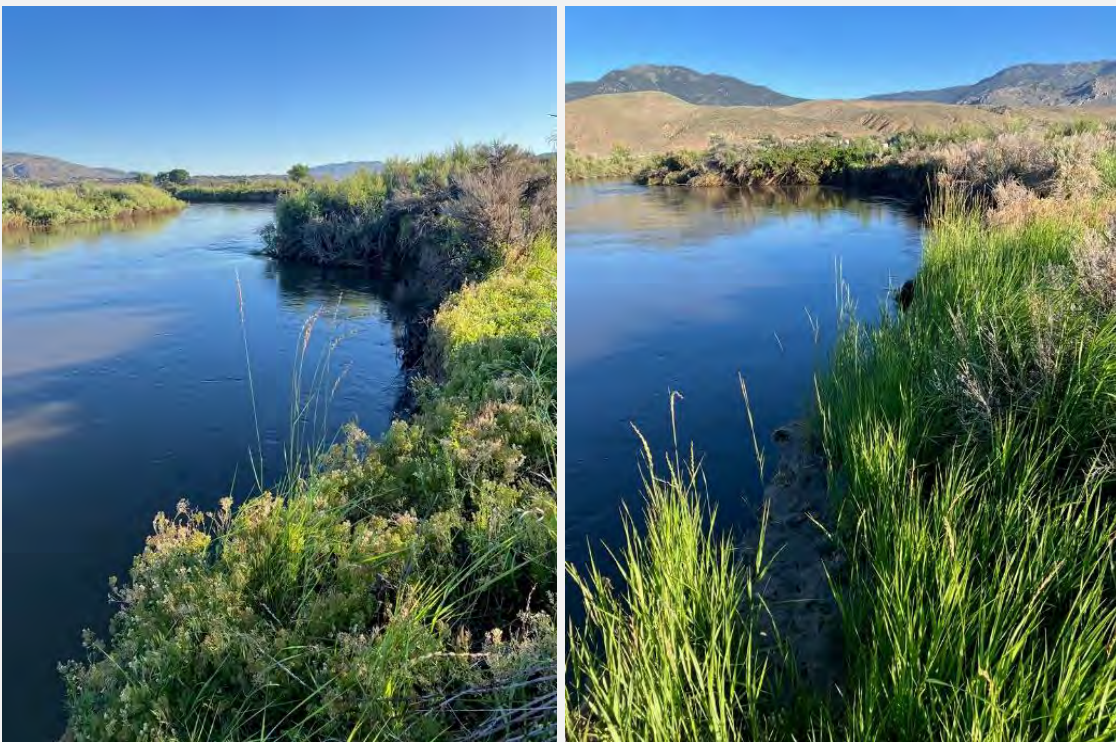
*Trail sections gone*

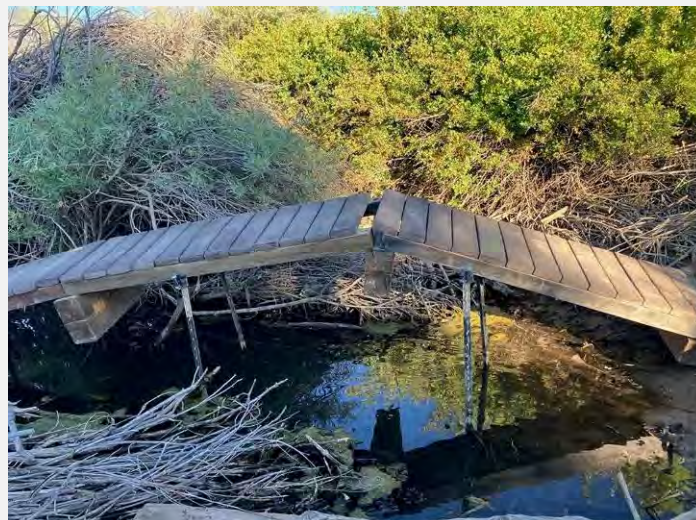
***Boardwalk damage/maintenance***

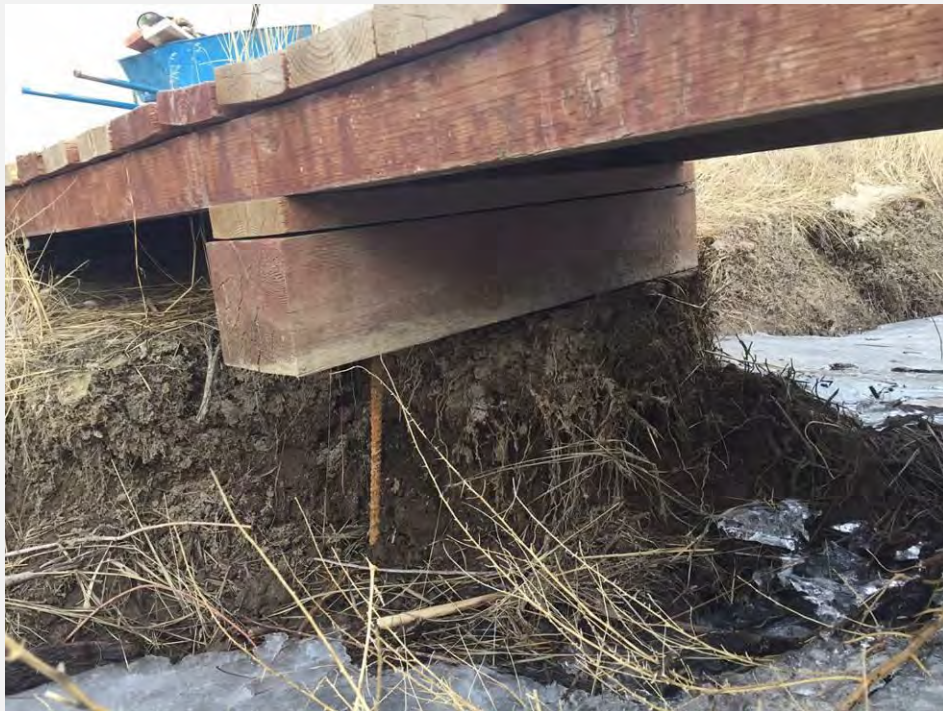
***Boardwalk damage/maintenance***

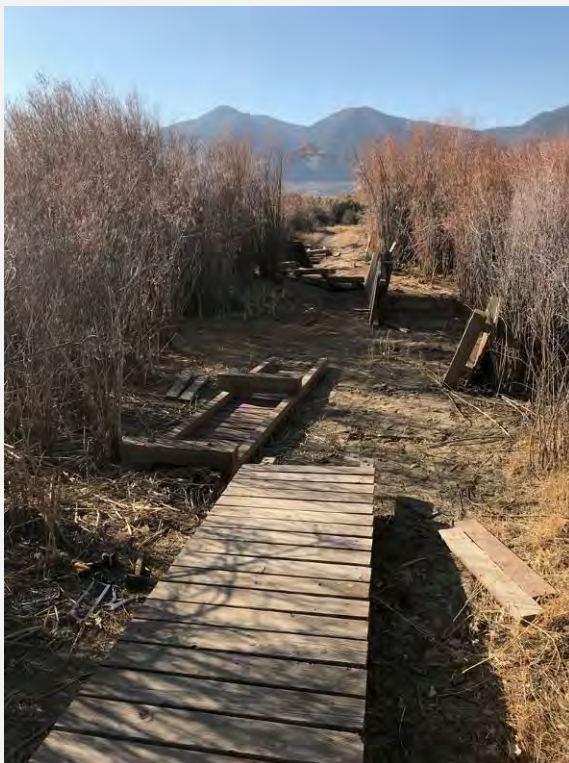
***Boardwalk damage/maintenance***

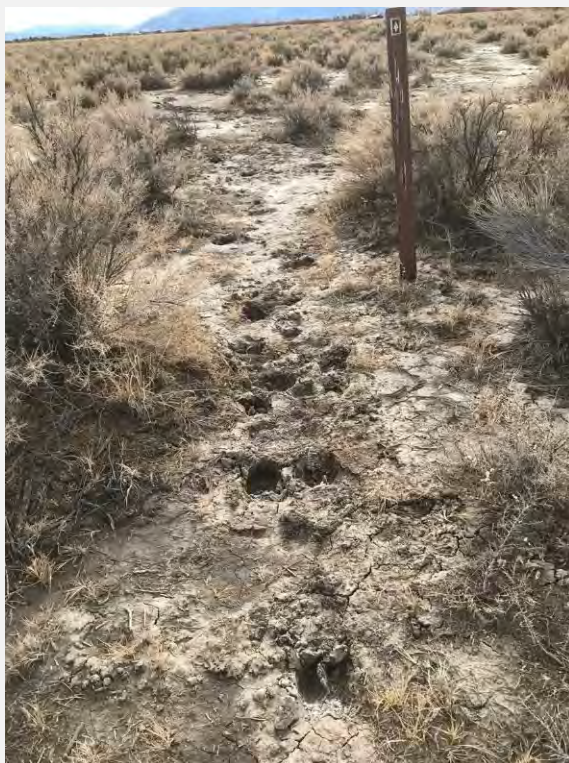
- d) Past cattle grazing, particularly during mid-late fall, has caused extensive post-holing of the trail, making it difficult and treacherous to walk on. These holes are often several inches deep in cement-like clay soil, and can sometimes take days to repair across long trail sections.

***Cattle postholes***

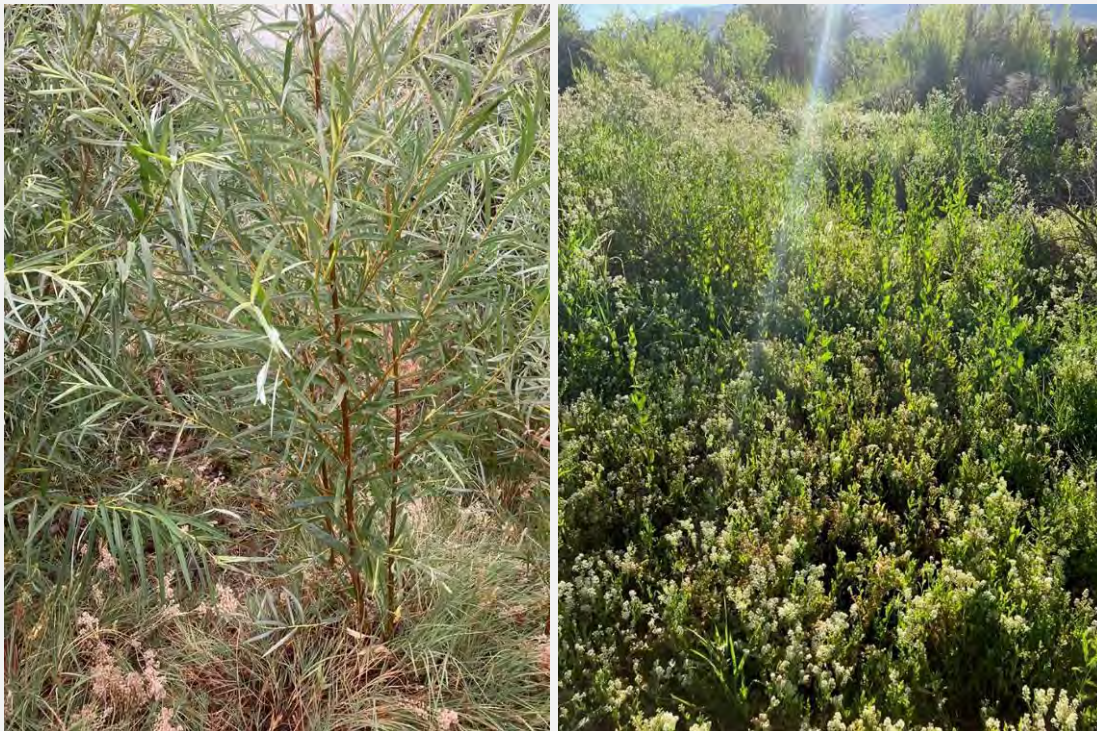
*Trail overgrown-lack of use and rapid growth*

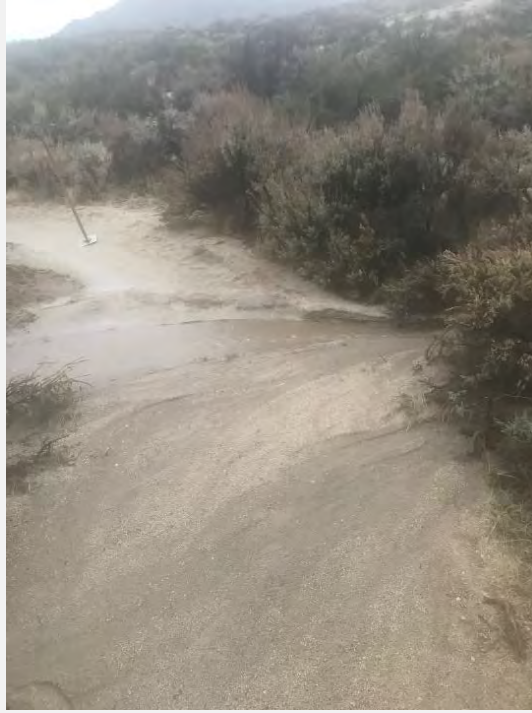
1) Pre-flood preparations were done on waterbars and ephemeral creek crossings prior to a couple flood events.

*Drainage maintenance*

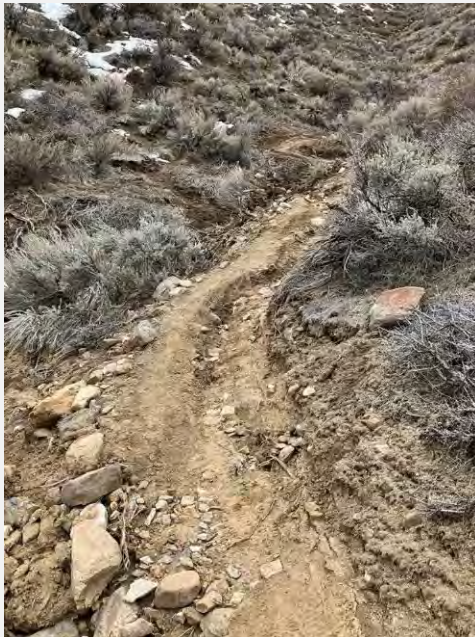
2) Two damaged trail sections from flood events were repaired and drainage improved on the lower Clear Creek Trail.

*Before*

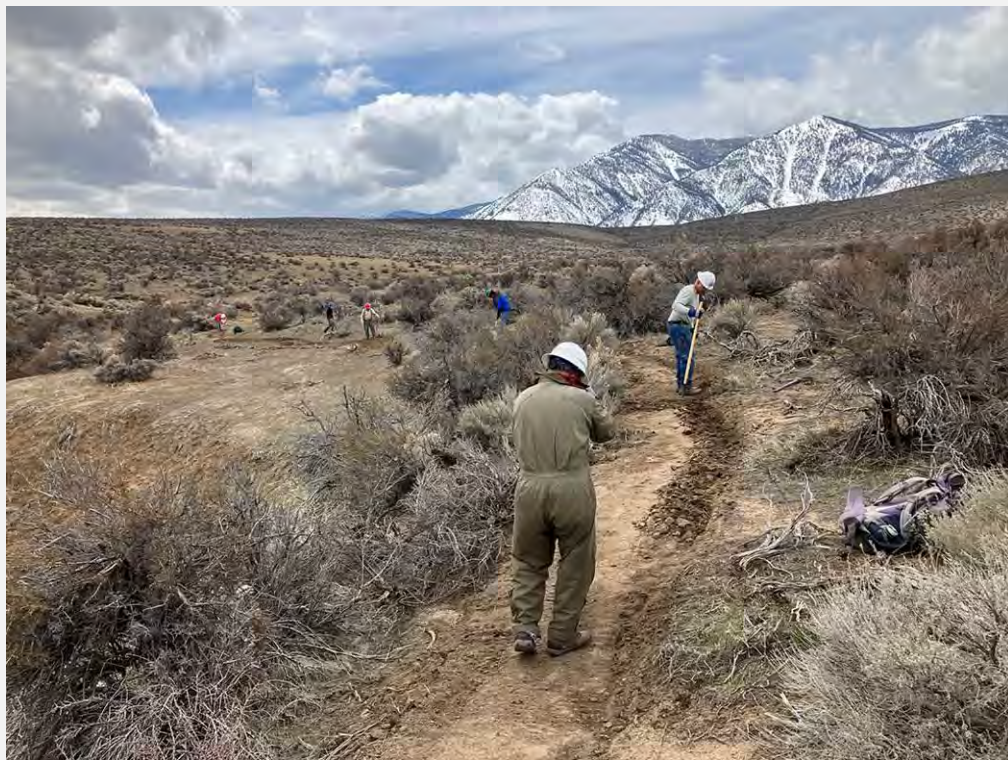
3) The 4.1-mile James Lee Loops was constructed and open.

*James Lee Loops Construction*

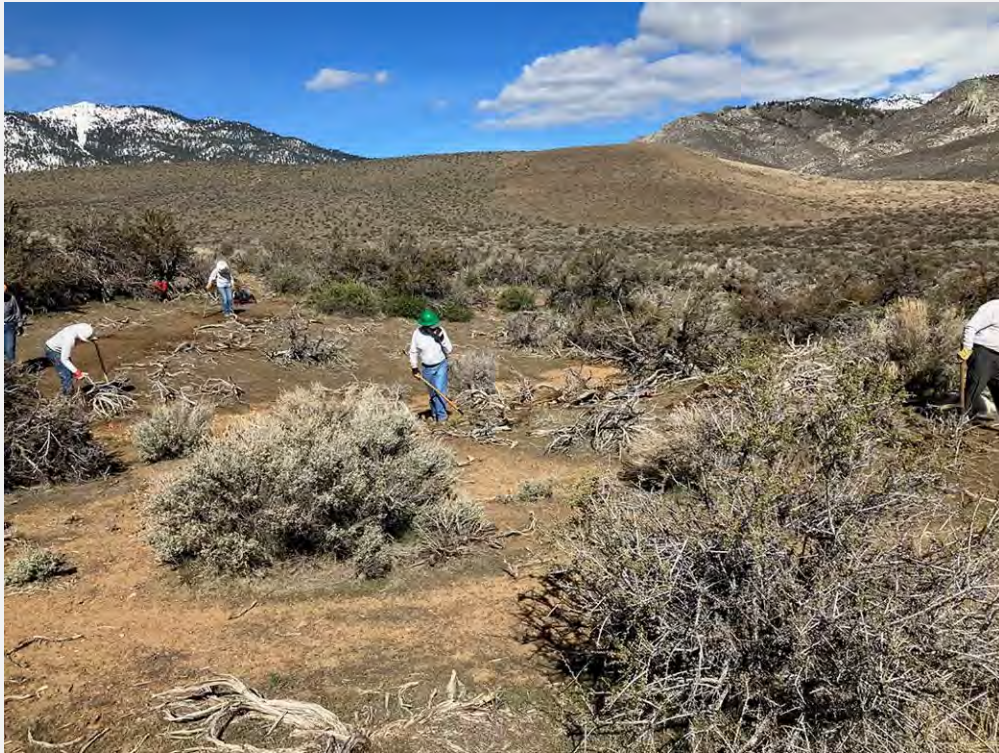
*James Lee Loops Construction*

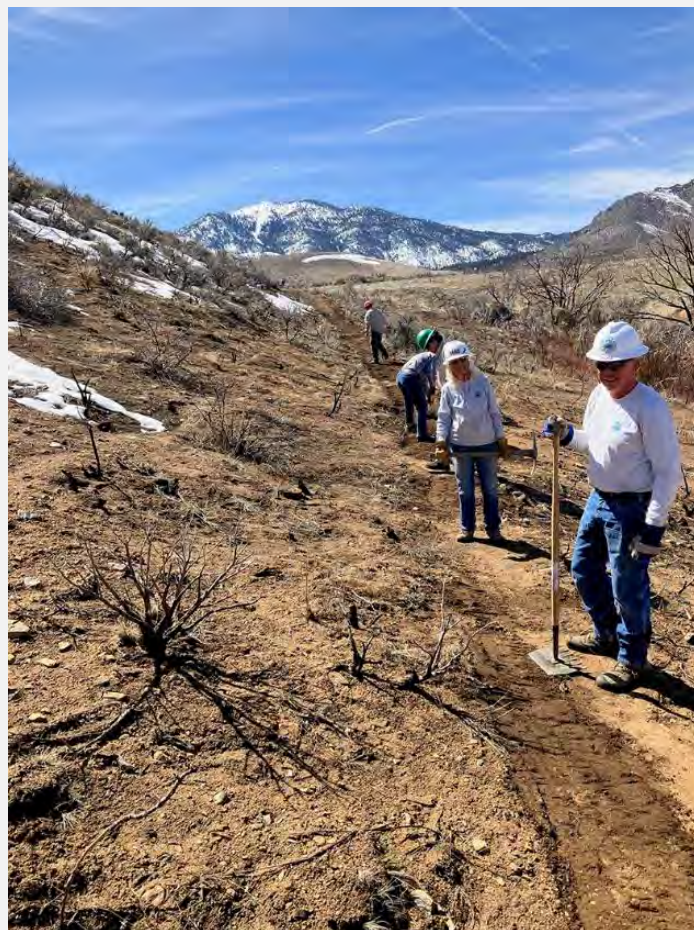
*James Lee Loops Construction*

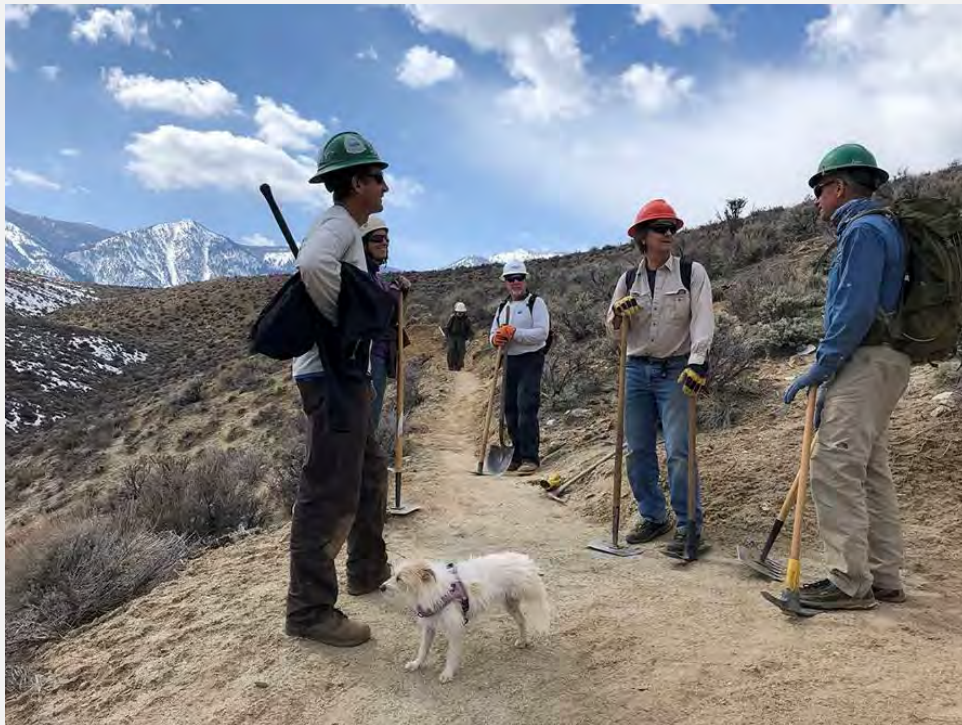
6) The entire 30-mile Clear Creek Trail System had routine maintenance completed twice including drains, brushing, and clearing of rocks and debris.

*Trail maintenance*

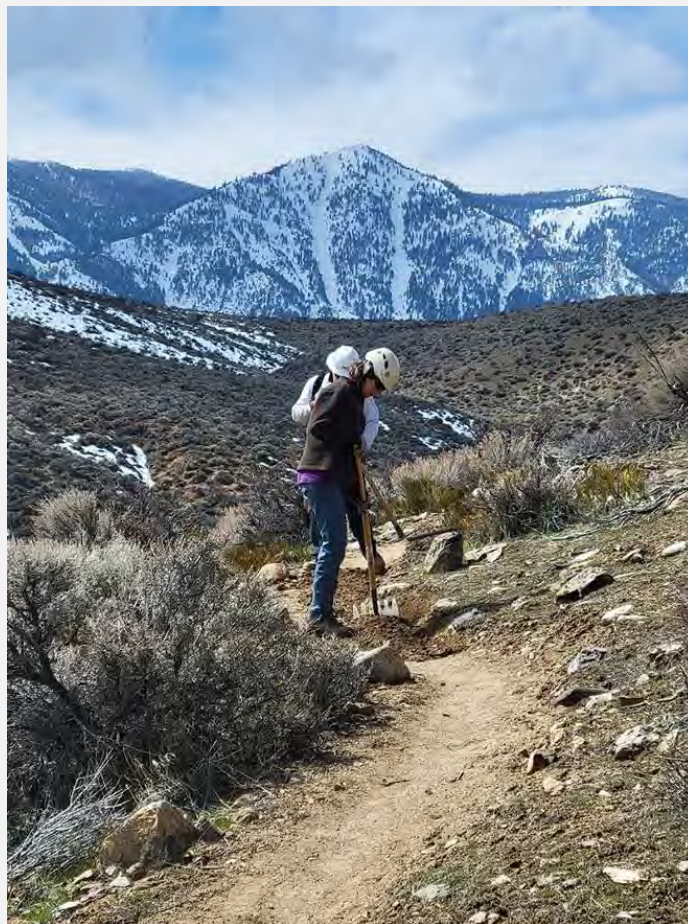
*Trail maintenance*

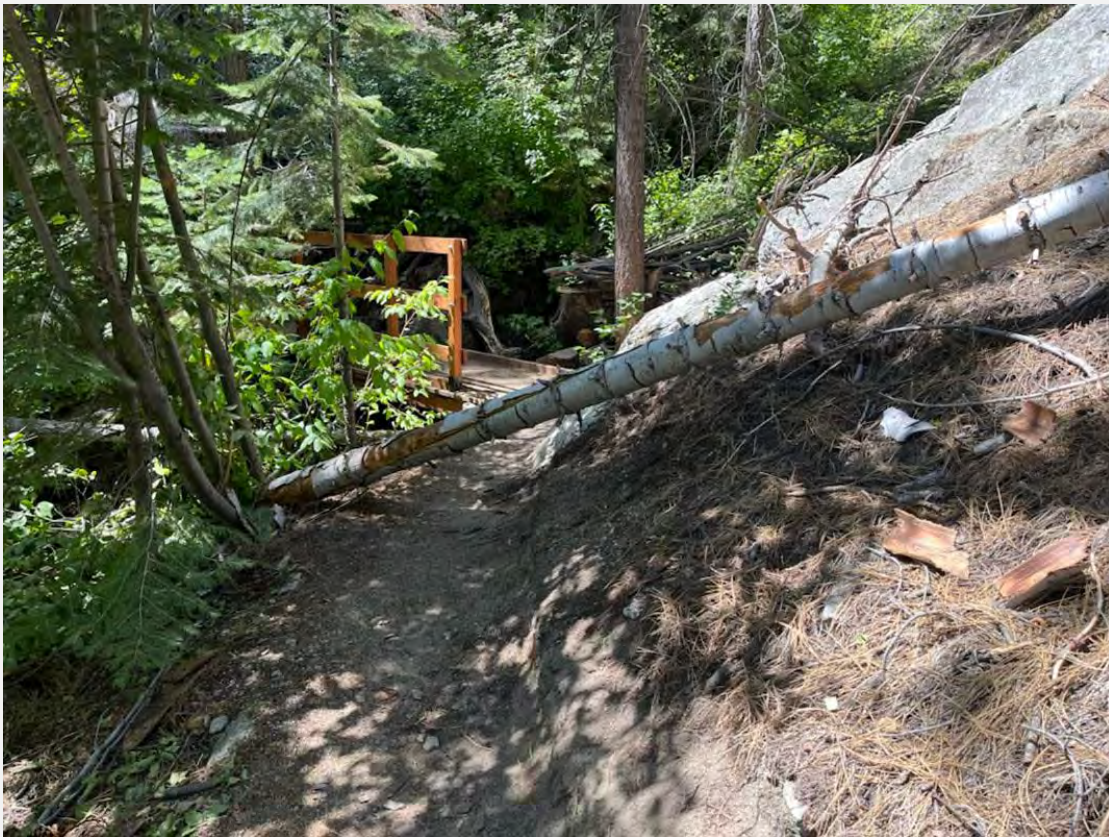
7) Eleven fallen trees were removed from the trail.

*Tree removed*

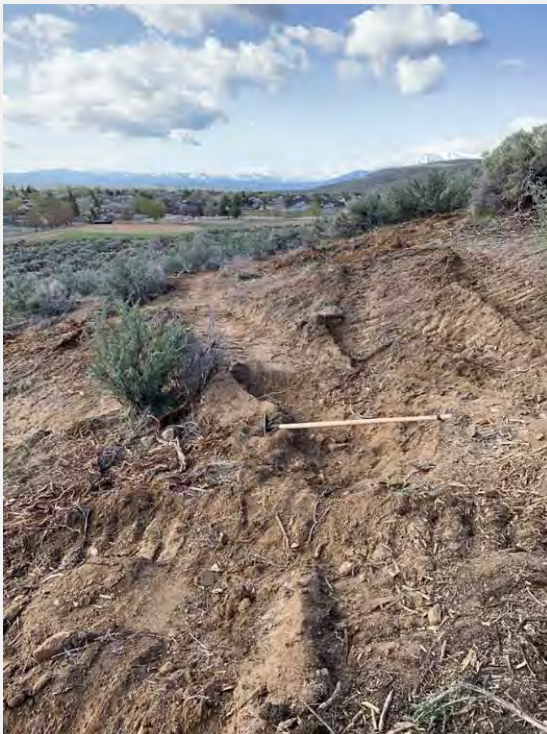
8) Brush mastication work damaged a couple sections of the James Lee Loops. These areas were repaired.

*Before*

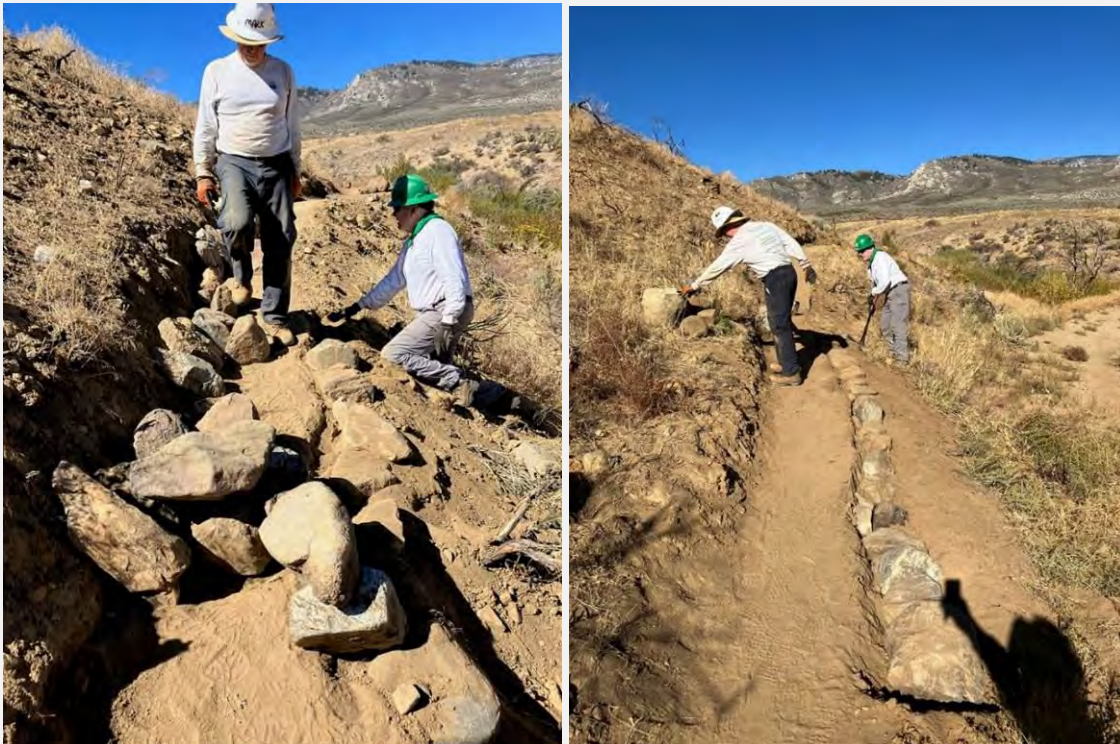
11) A 70-foot section of the James Lee Loops was armored with rocks to maintain the critical edge and trail width.

*Tread armoring*

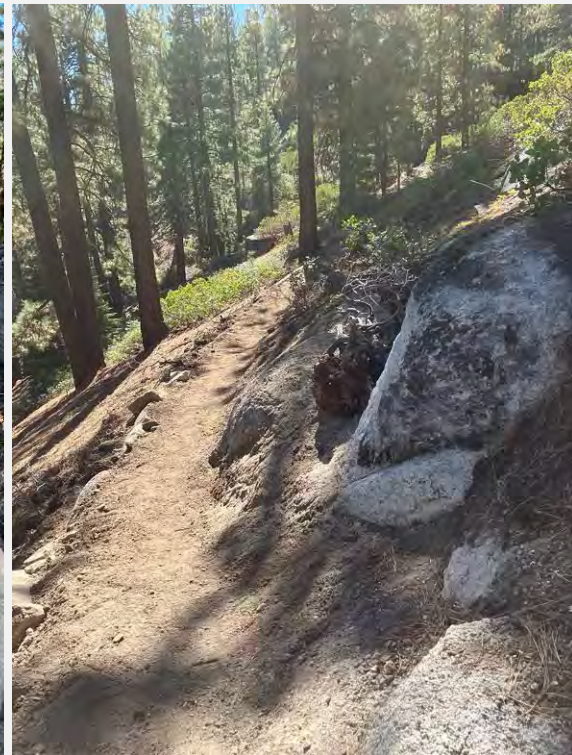
13) A 70-foot section of the Clear Creek Trail between Cliff Rock and Finger Gap Rock was realigned to avoid a blind turn and remove the trail off slickrock. This improves sightline and safety for all trail users.

*Realignment*

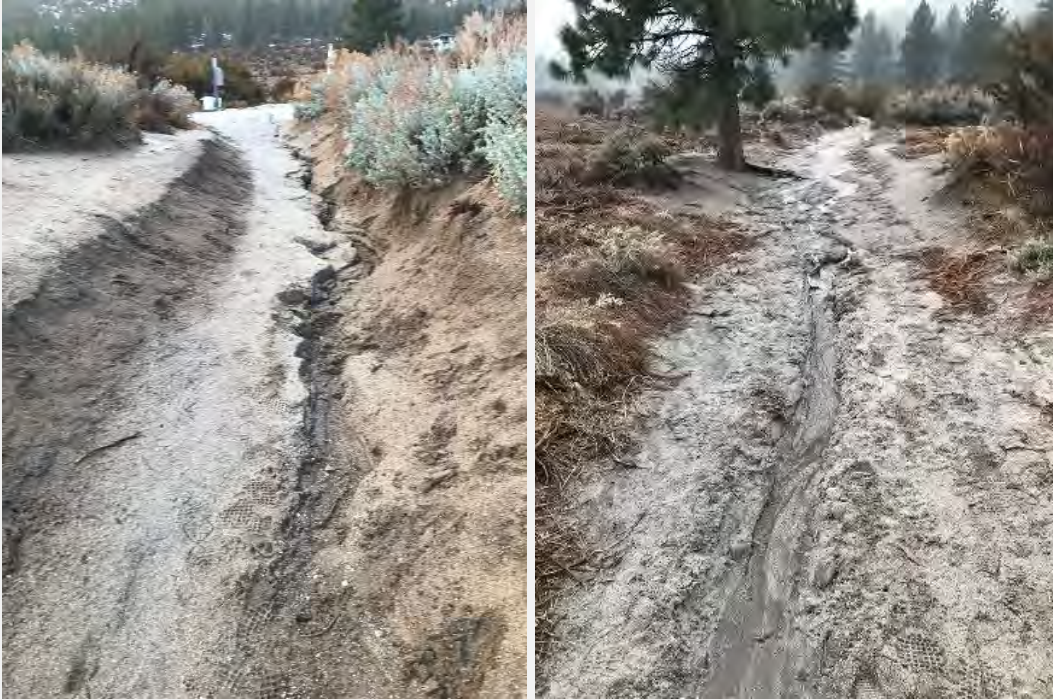
- 1) Routine storm damages were repaired on the old road segments of the trail system.

***Trail damage repaired on road segments***

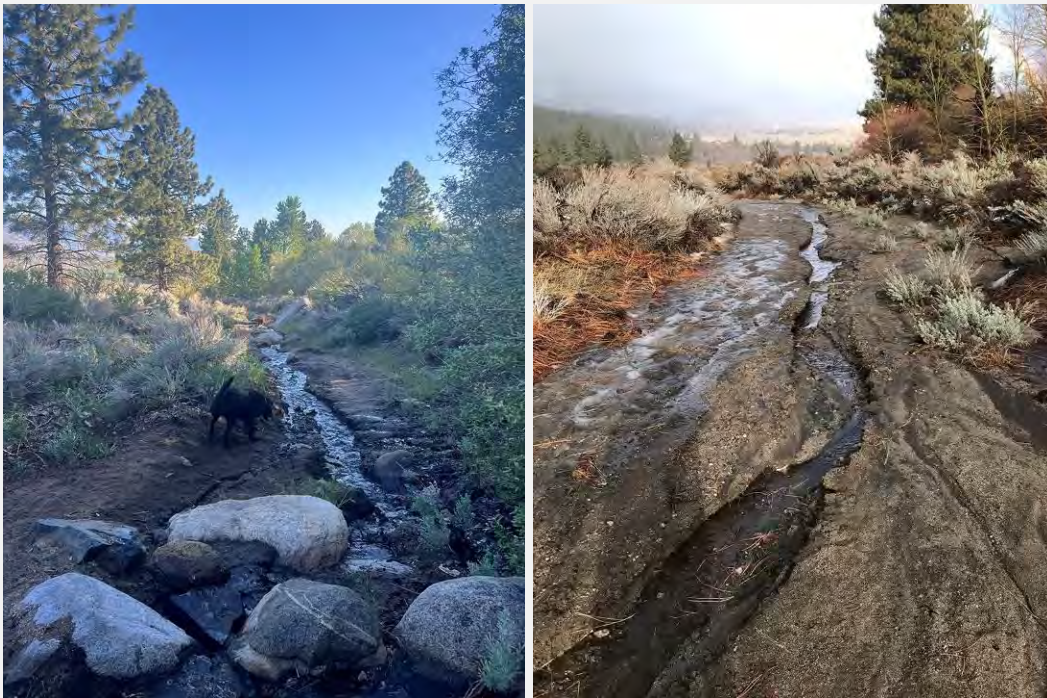
***Trail damage repaired on road segments***

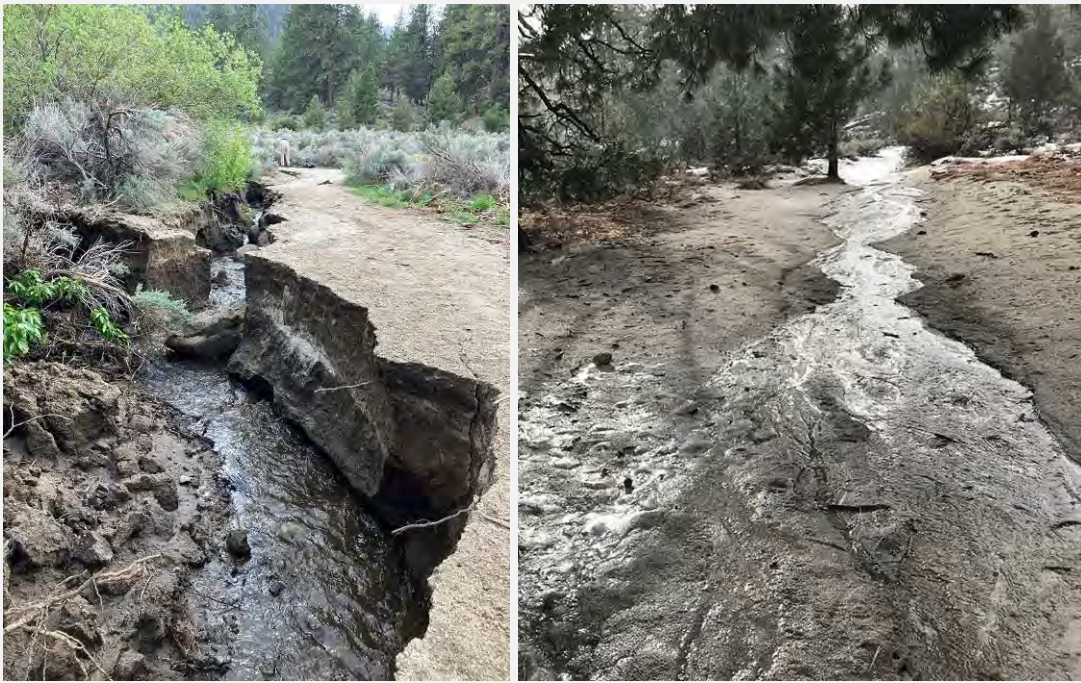
*Trail damage repaired on road segments*

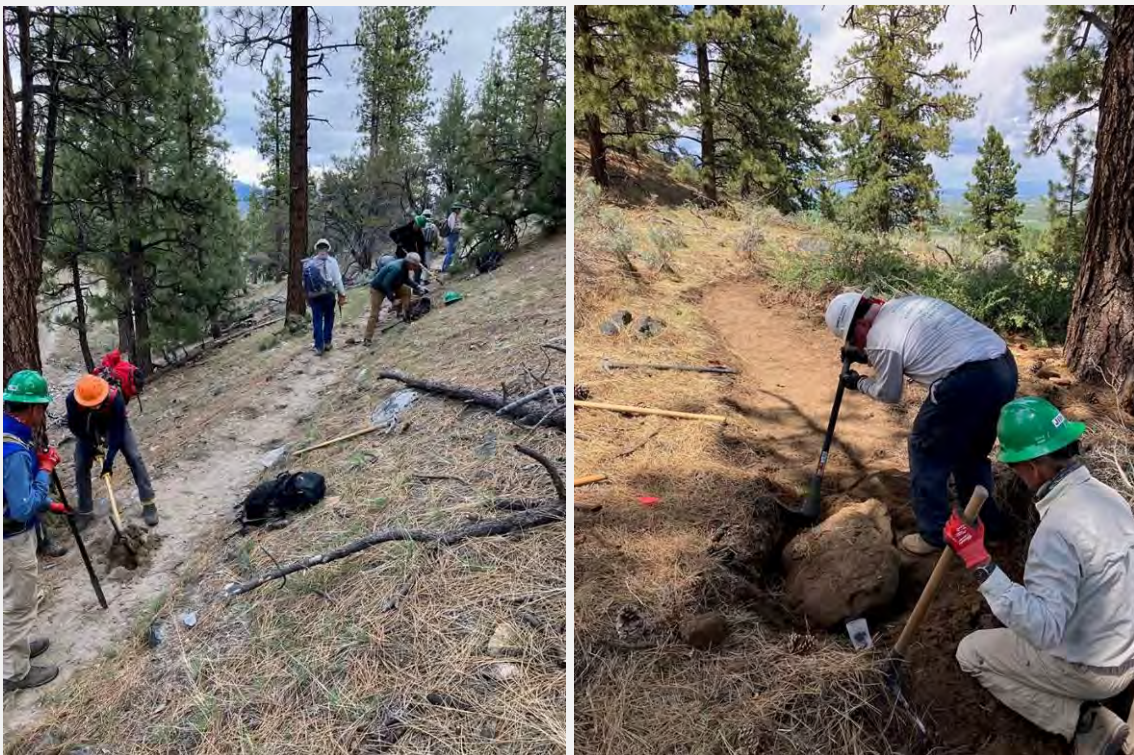
*Rocks removed*

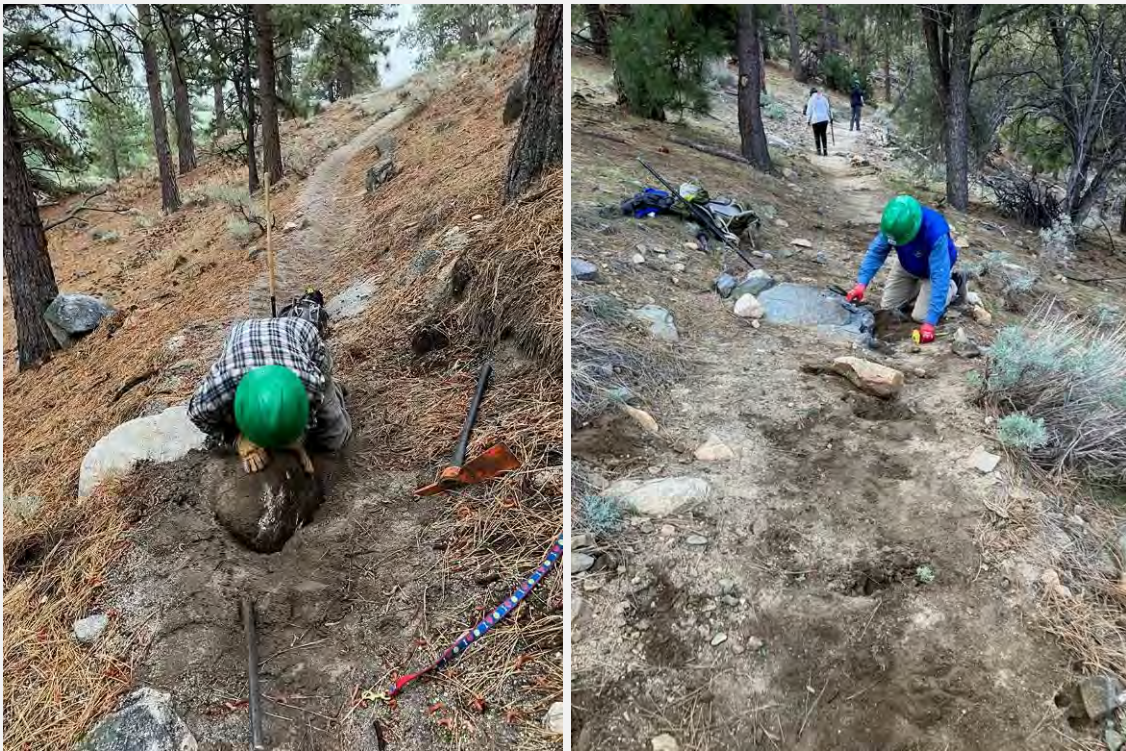
***Rocks removed***

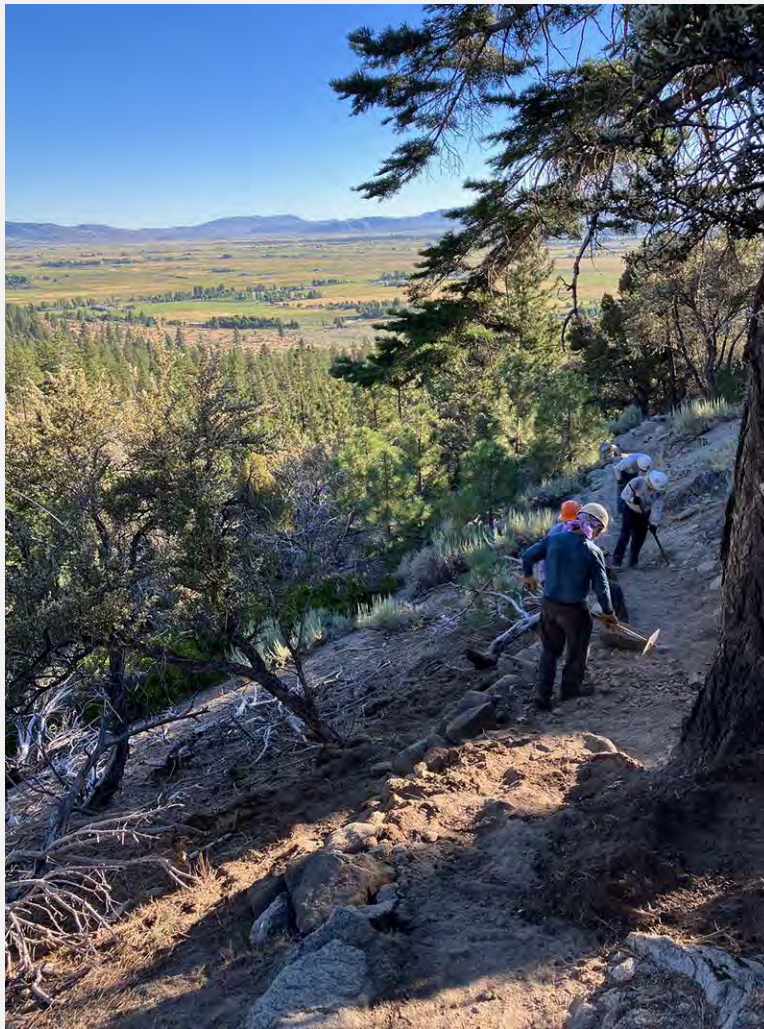
7) Tread widening and removal of roots, rock and slickrock was completed on the Grand View Loop to provide safer equestrian passage. Waterbars were also replaced with grade reversals on many areas to eliminate ongoing cleanout maintenance and prevent further trail rutting.

*Root, rock and slickrock clearing*

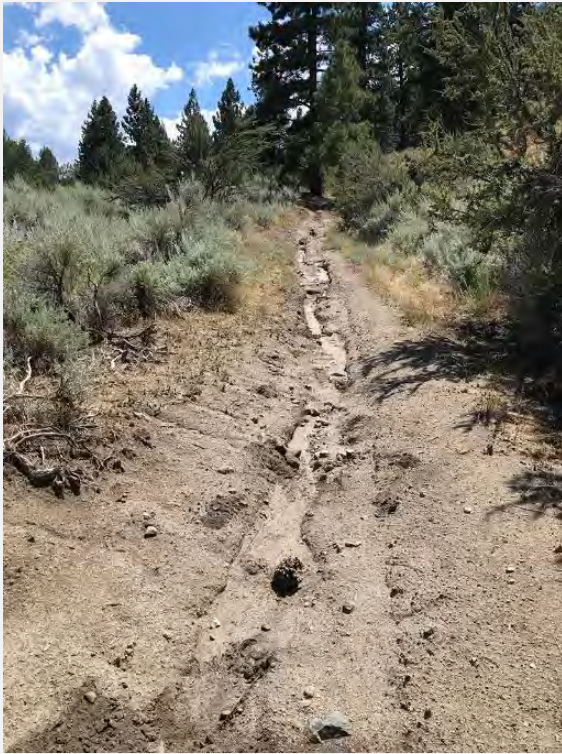
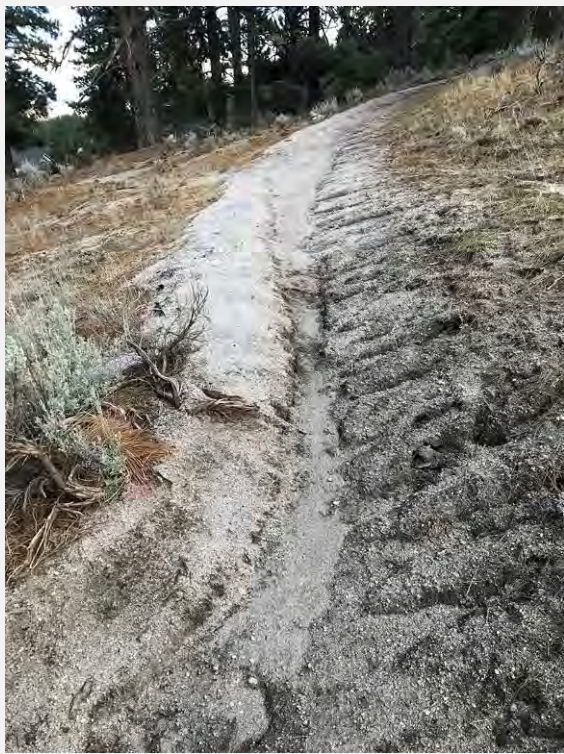
8) Several realignments were completed. These generally provide a more enjoyable and less steep route with far less maintenance needed. Most bypass old road segments that rut and entrench from captured water over long lengths. Aligning the formal trail to a long-term sustainable location that contours the landscape eliminates the need to continuously rebuild waterbars and repair storm damaged tread. Most road segments remain open to use to further disperse users and provide additional user options, but will no longer be maintained. Some realignment benefits include:

*Rutted and entrenched examples*

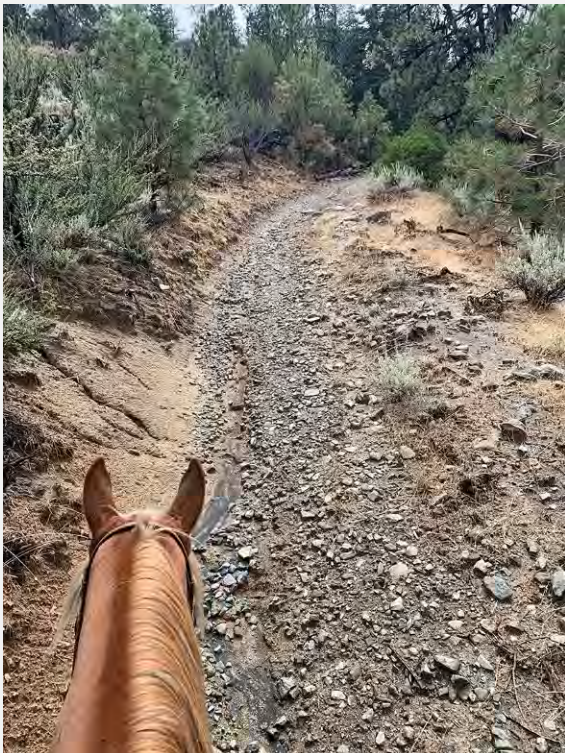
*Rutted and entrenched examples*

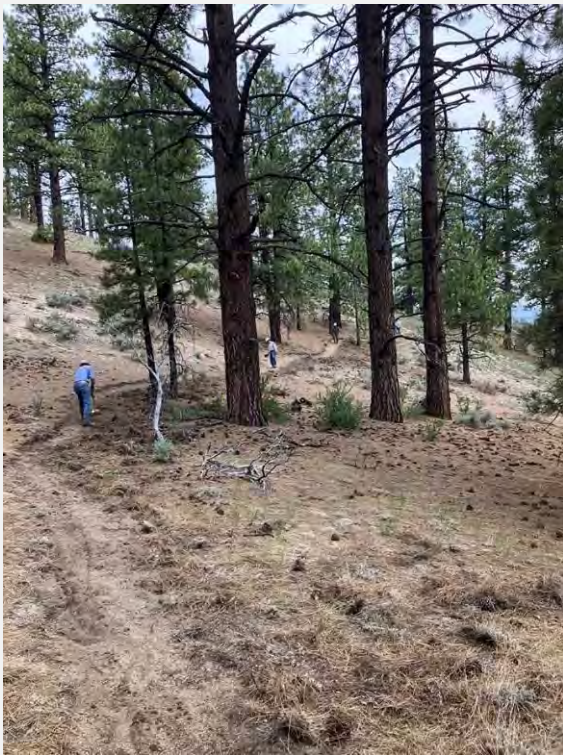
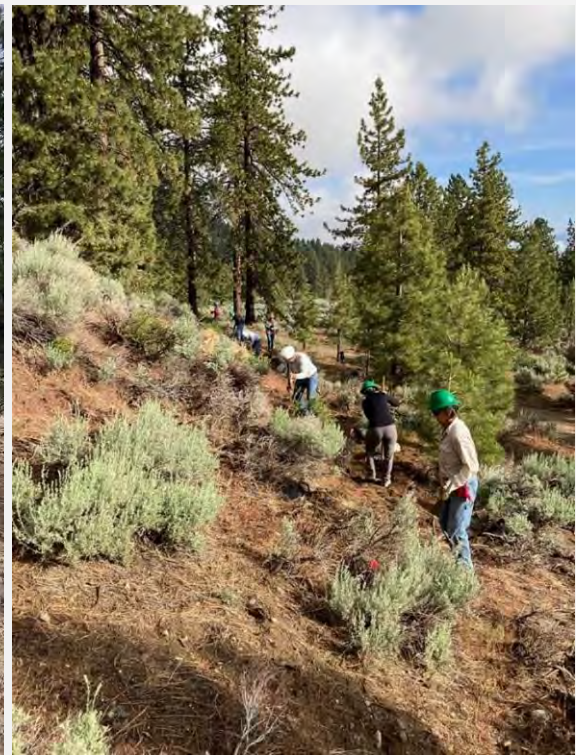
*Realignment*

- a) Eliminates continuous waterbar maintenance
- b) Contours the terrain and blends into the landscape instead of counter to it
- c) Meets trail sustainability standards for trail longevity
- d) Prevents excessive, redundant and unnecessary long-term maintenance
- e) Frees up valuable maintenance time
- f) Regularly diverts water off the trail through grade reversals instead of capturing water for long lengths that cause ruts and further entrenching
- g) Gives the user experience a more trail-like feel instead of a road feel
- h) Less steep than road segments
- i) Greatly reduces soil displacement and transport
- j) Provides a more scenic and enjoyable route
- k) Bypasses slippery slickrock sections for better footing
- l) Less icy in winter due to flatter grade and less water flow and collection

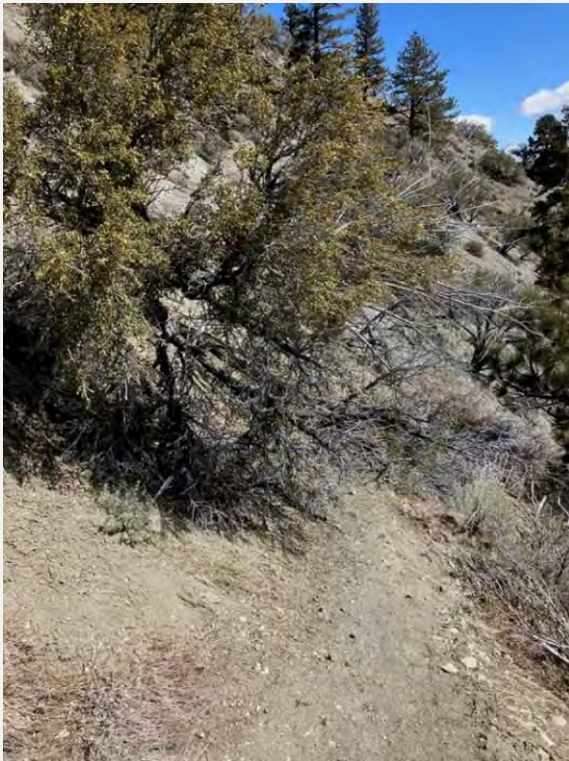
1) Eighteen fallen trees were removed from the trail system.

*Before*

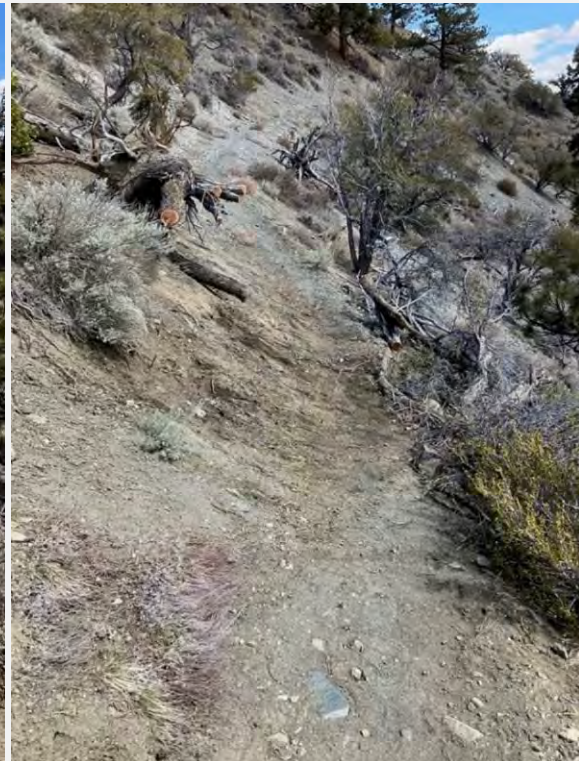
*After*

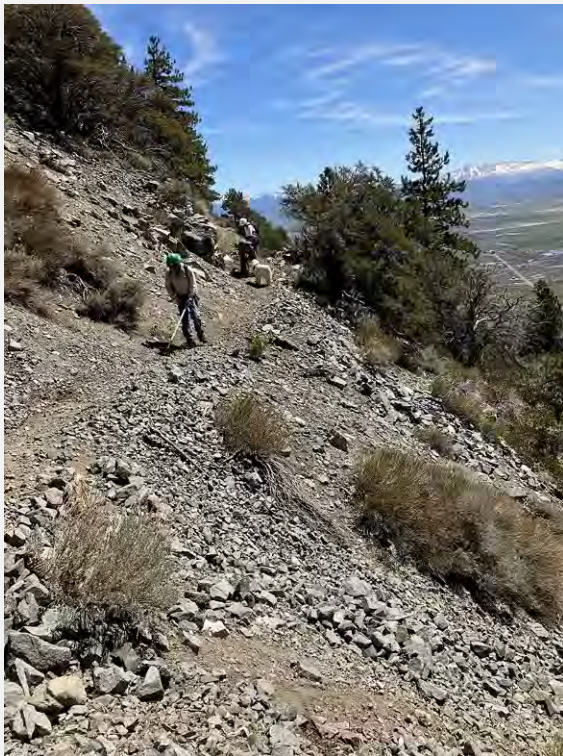
2) The entire trail system was cleared of rockfall, slough and debris.

*Rock and debris clearing*
