# Carson Valley Trails Association

## 2023 Trail Operations Overview and 2024 Trail Work Plan

# Carson Valley Trails Overview-2023

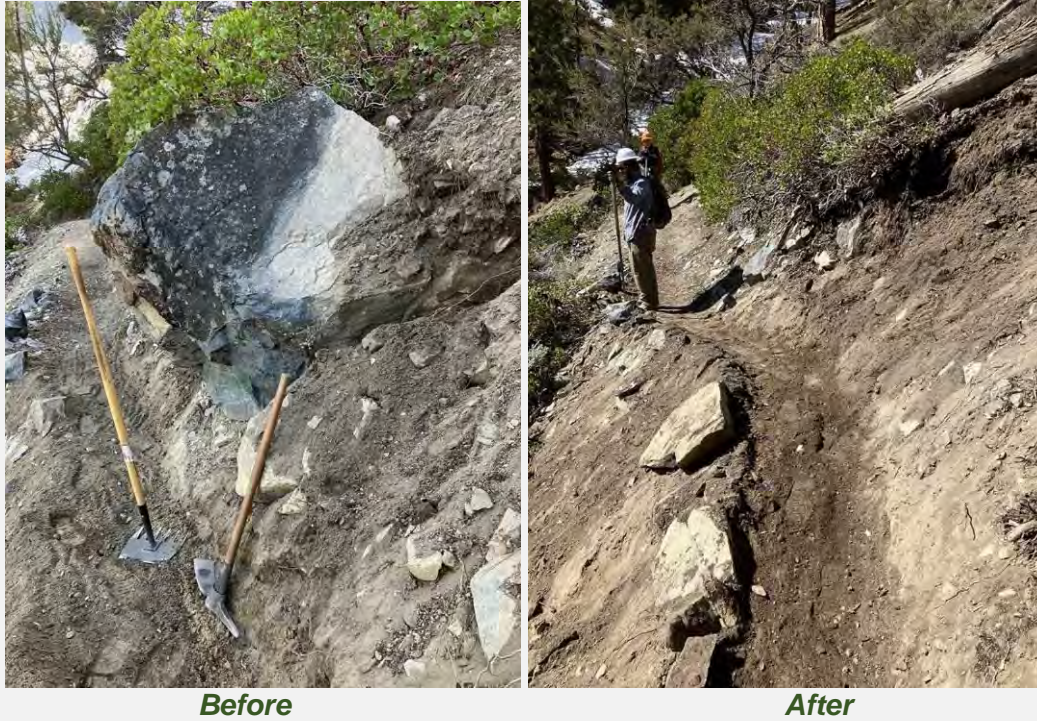
3) Two large boulders that slumped and blocked the Genoa Loop were removed.

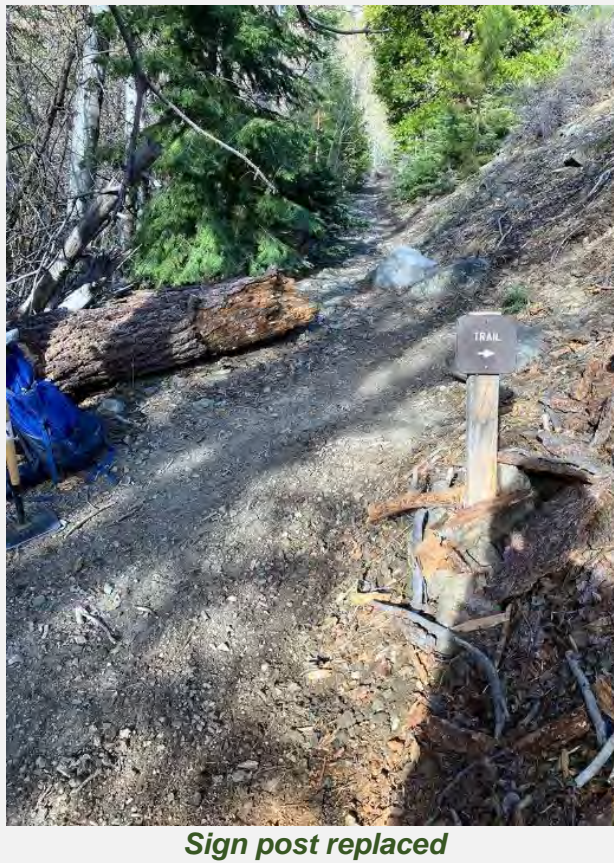
4) A sign post crushed by a fallen tree was replaced.

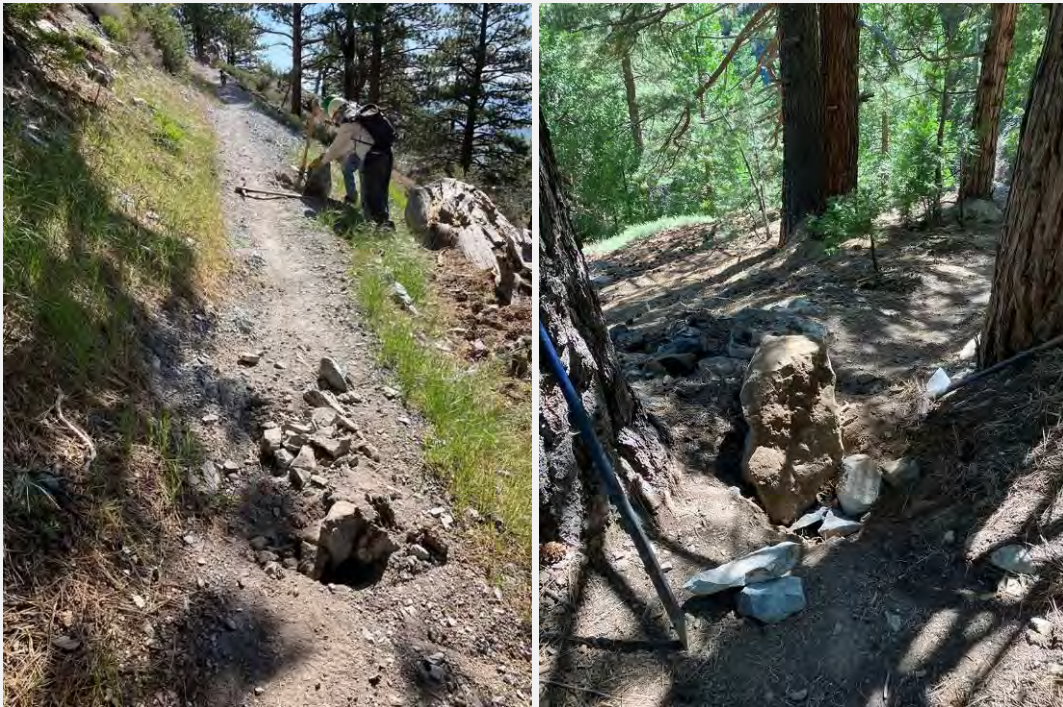
6) Thousands of protruding rocks and boulders were extracted from the trail system to provide safer and more enjoyable access for mountain bikers, and better footing for hikers and equestrians.

*Rocks and boulders removed*

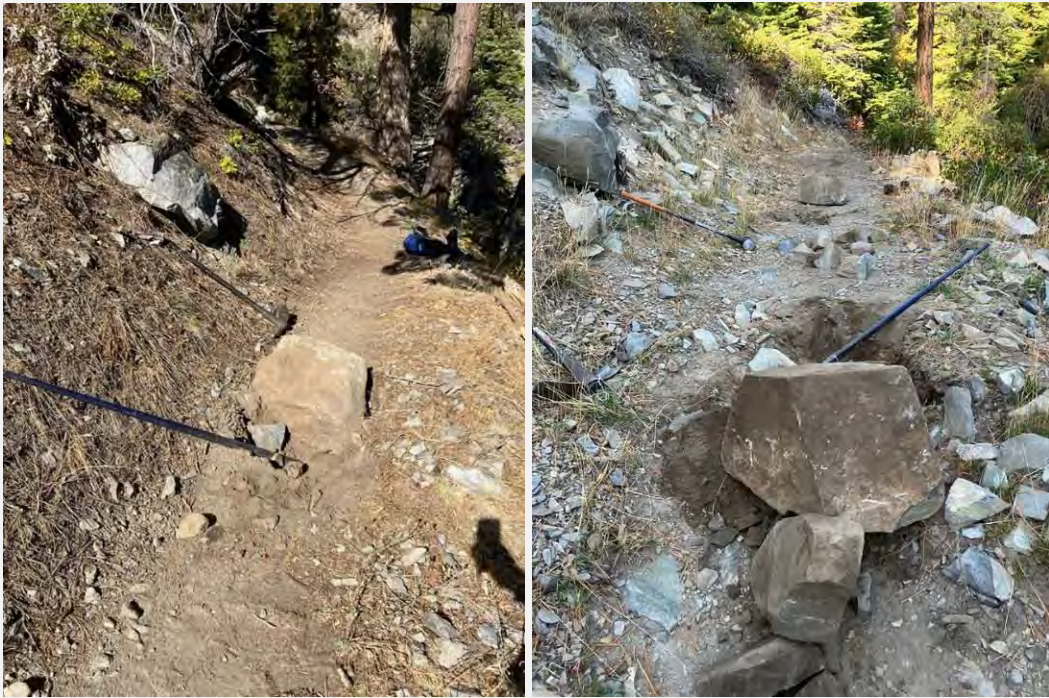
***Rocks and boulders removed***

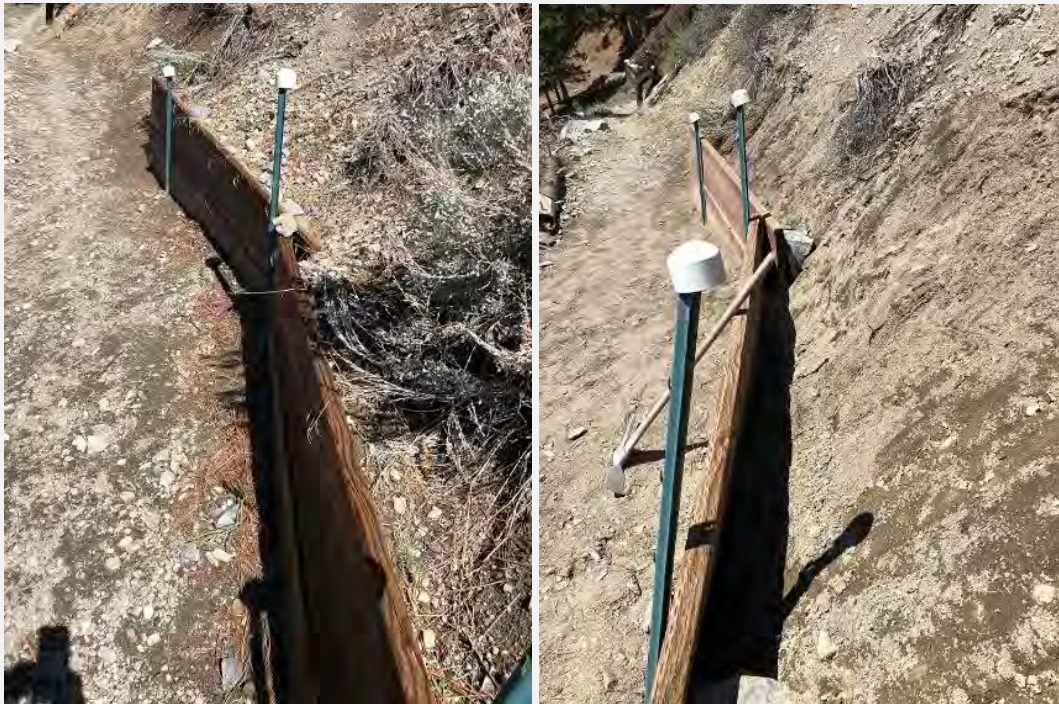
7) All retaining walls were cleaned out.

***Before***

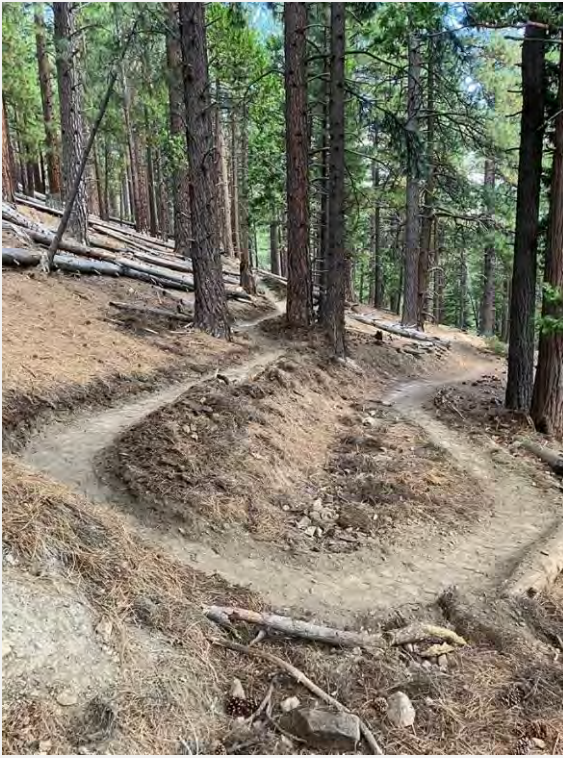
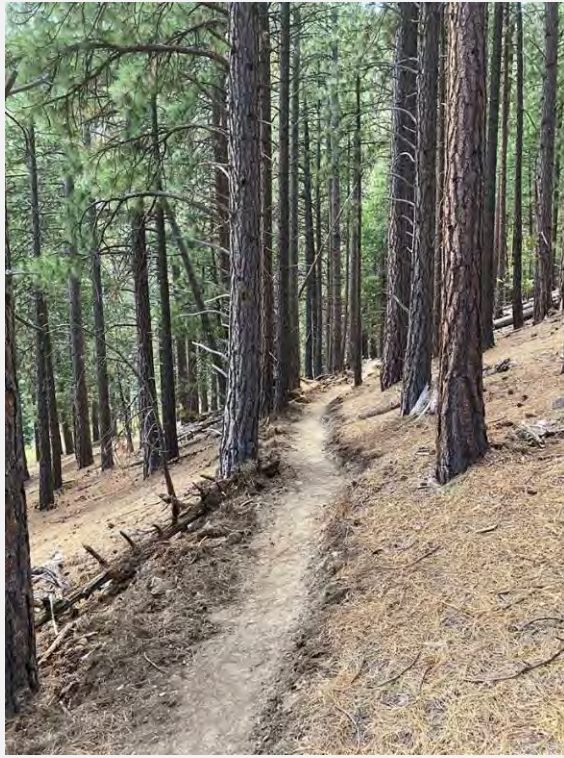
8) An 80-foot and 90-foot realignment was completed on the Sierra Canyon Trail to replace steep 35% grades to sustainable 8% grades. A longer quarter-mile realignment was also completed to replace a sustained 17% grade with a 7% grade. These provide safer downhill bike speeds and removes unnecessary elevation gain and loss.

*Realignment*

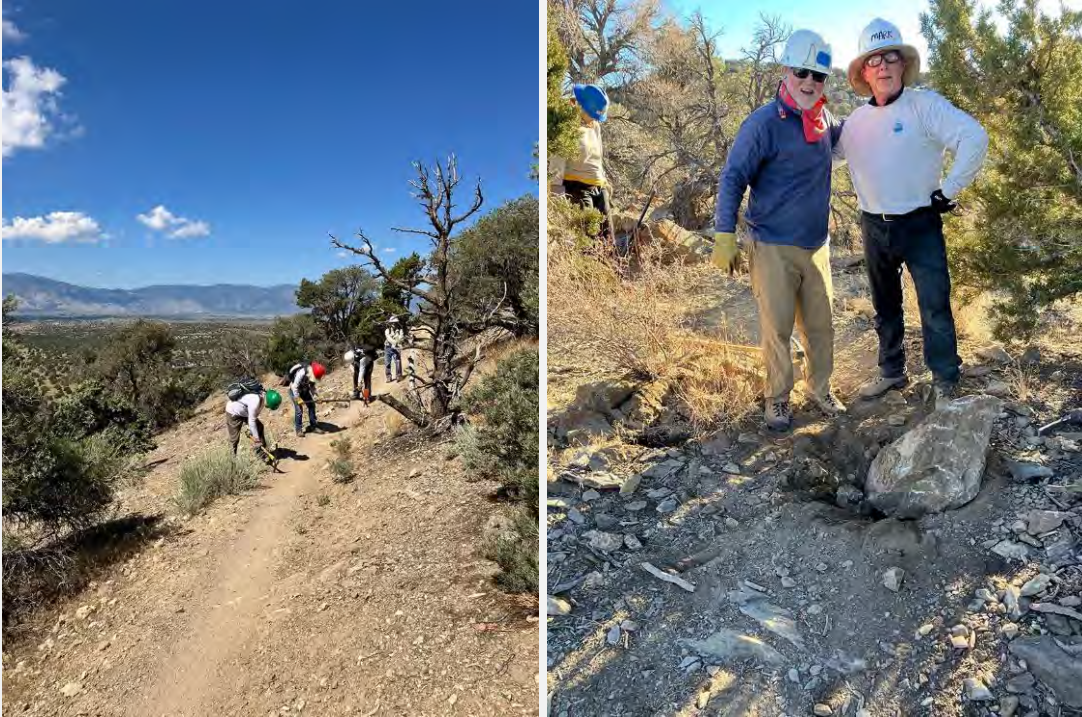
- 1) Dozens of snow-loaded snapped limbs across the trail were removed.
- 2) Rock removal, brushing and tread maintenance was completed on the trail.

*Routine maintenance*
